## **Crack Repairs At Capitol Dome**

# Capitol Architect Pushes To Restore Iconic Dome

The project team is executing a massive preservation effort while maintaining public access **BY BRUCE BUCKLEY**

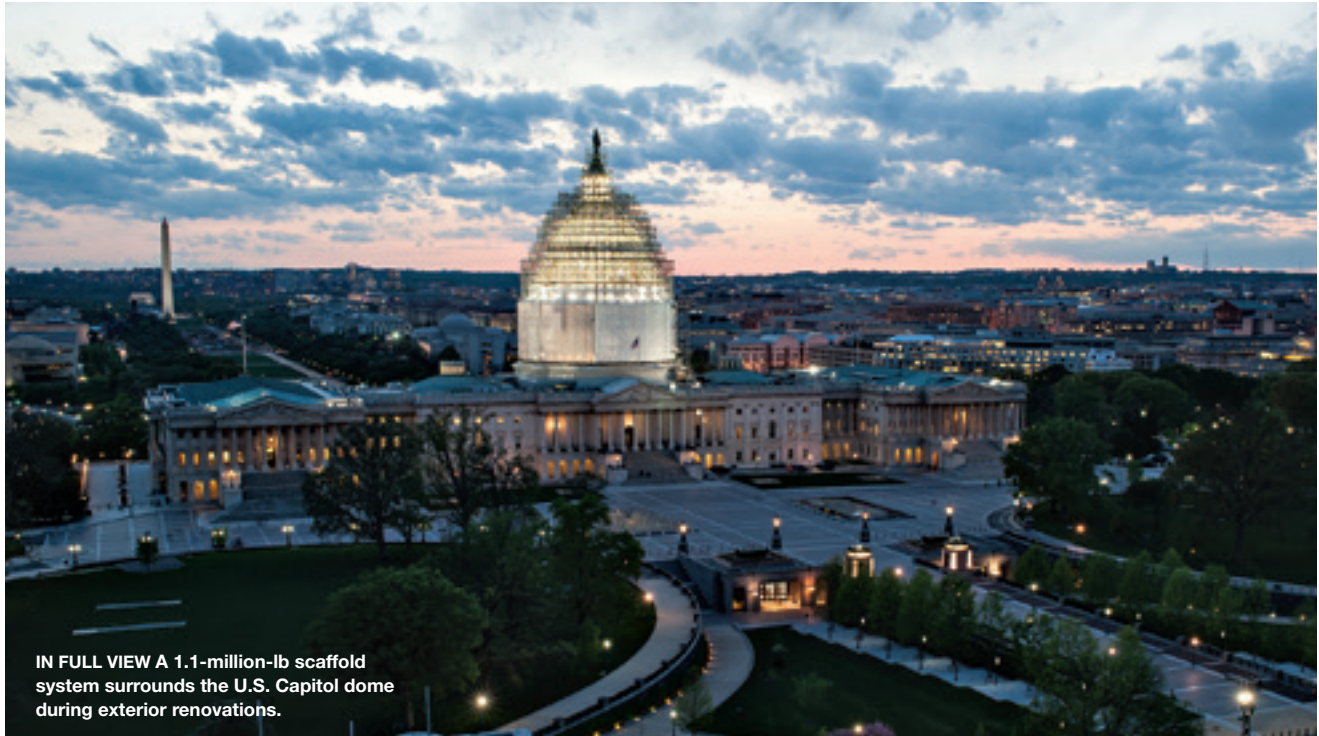
IN FULL VIEW A 1.1-million-lb scaffold system surrounds the U.S. Capitol dome during exterior renovations.

Based on the AOC designs, the team identified where the scaffold system could place load on the structure. The entire scaffold system, weighing more than 1.1 million lb, places its loads on the structural ribs of the dome rather than its surface. The vertical load is entirely supported on 36 points at the "peristyle" level, near the skirt at the base, and the "boilerplate" level, at roughly one-third of the way up the dome. On the "tholos" level, located at the top of the dome, the system is only supported to prevent horizontal movement of the scaffold.

The completed system featured more than 75,000 pieces of equipment, 52 miles of scaffold pipe and two miles of decking.

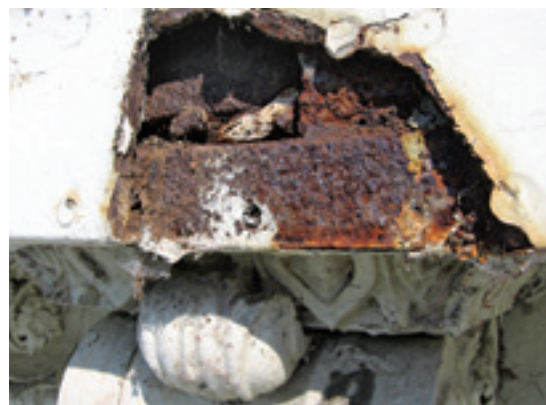
**RUST TO DUST**  
Significant portions of the cast iron dome have corroded and will need to be recast and replaced.

While AOC intends to preserve as much of the existing dome as possible, hundreds of new ornamental pieces will need to be cast to replace those that are beyond repair. Crews are carefully removing and cataloging damaged pieces before shipping them to specialty contractor Historical Arts and Casting's Utah foundry. In some cases, a single mold is cast for identically designed pieces, such as the multiple 80-lb ornamental acorns that are attached to the outside of the dome. In other cases, each piece needs its own mold to ensure it will fit properly when installed. Crews found significant damage to the boilerplate balustrade, with up to 3 in. of corroded material found in some spots. All of the 288 balusters will be removed and many will be recast with unique molds.

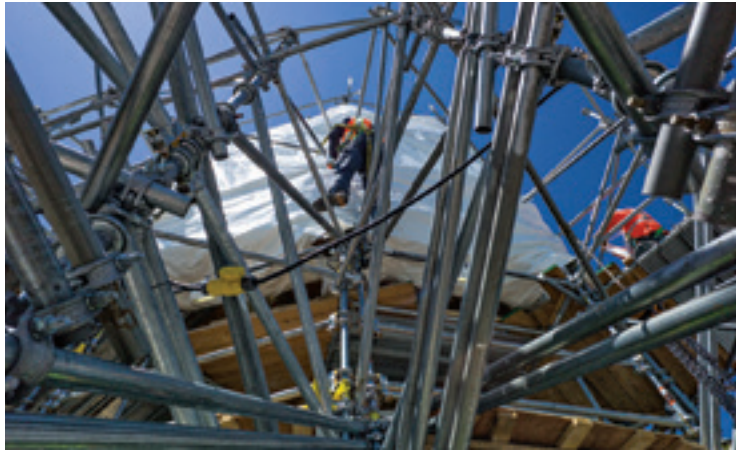
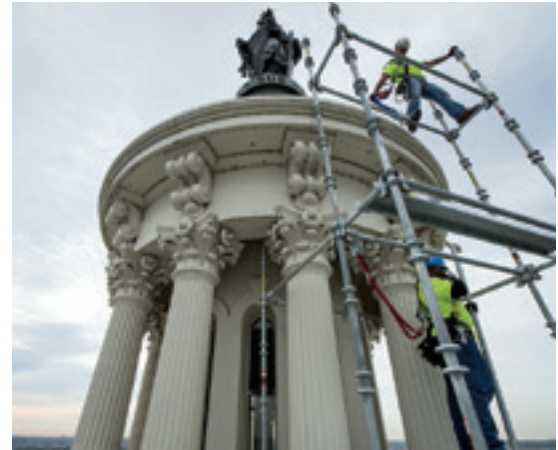
**CARRY THAT WEIGHT** The scaffold places the vertical loads at the lower portions of the dome. The top of the system is designed to only stabilize horizontal movement.

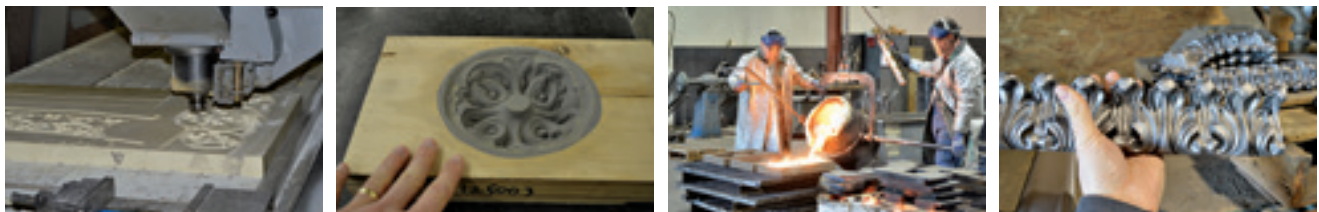
## Replicating the Dome's Damaged Components

Damaged ornamental elements and other components from the U.S. Capitol dome are sent to a foundry in Utah operated by Historical Arts and Casting and molds are created from existing pieces and fragments. Replacement components are then cast from those molds. In some cases, one mold can be used to create multiple replacement pieces. In other cases, unique molds need to be used for pieces that have to fit perfectly into existing spaces.

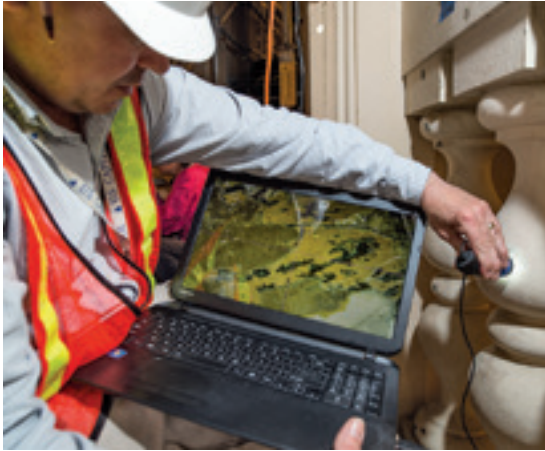
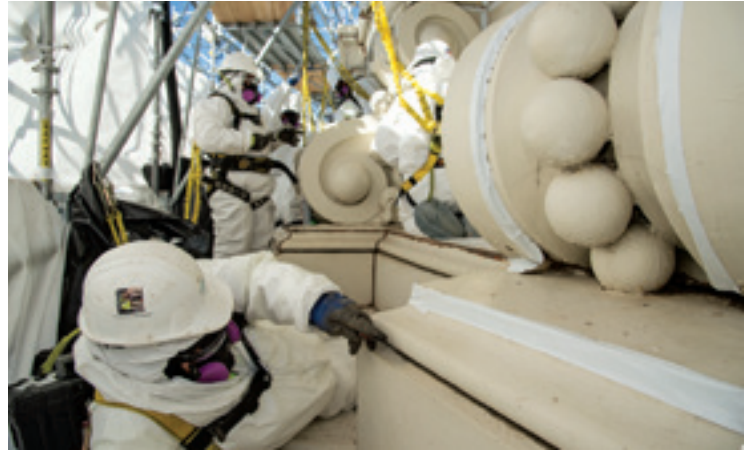
**INSPECT AND IMPROVE** Crews survey the extent of damage to cast iron elements (left). Throughout the project, existing paint (right) will be abated and replaced with 1,215 gallons of new paint.

Throughout the process, significant paint abatement is also required. An estimated 1,215 gallons of

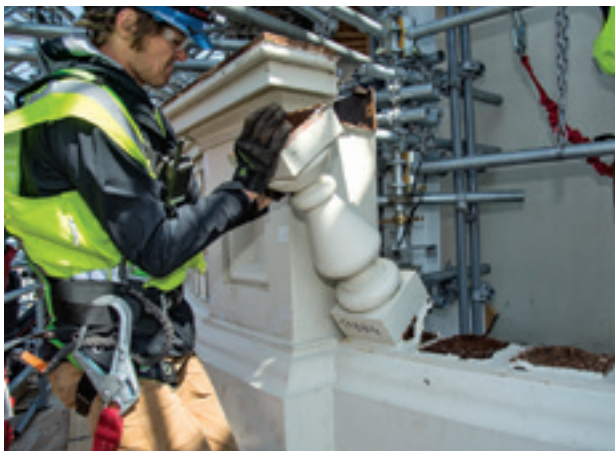
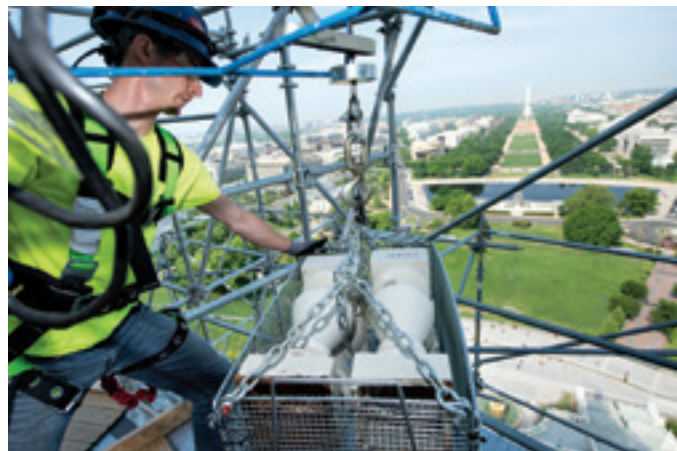
**RECAST AND REPLACE** All of the 288 balusters will be removed (left). Several will be sent to a foundry to be molded and recast.
